U.S. Fire Administration/Technical Report Series

Urban Wildlands Fire

Pebble Beach, California

USFA-TR-007/May 1987

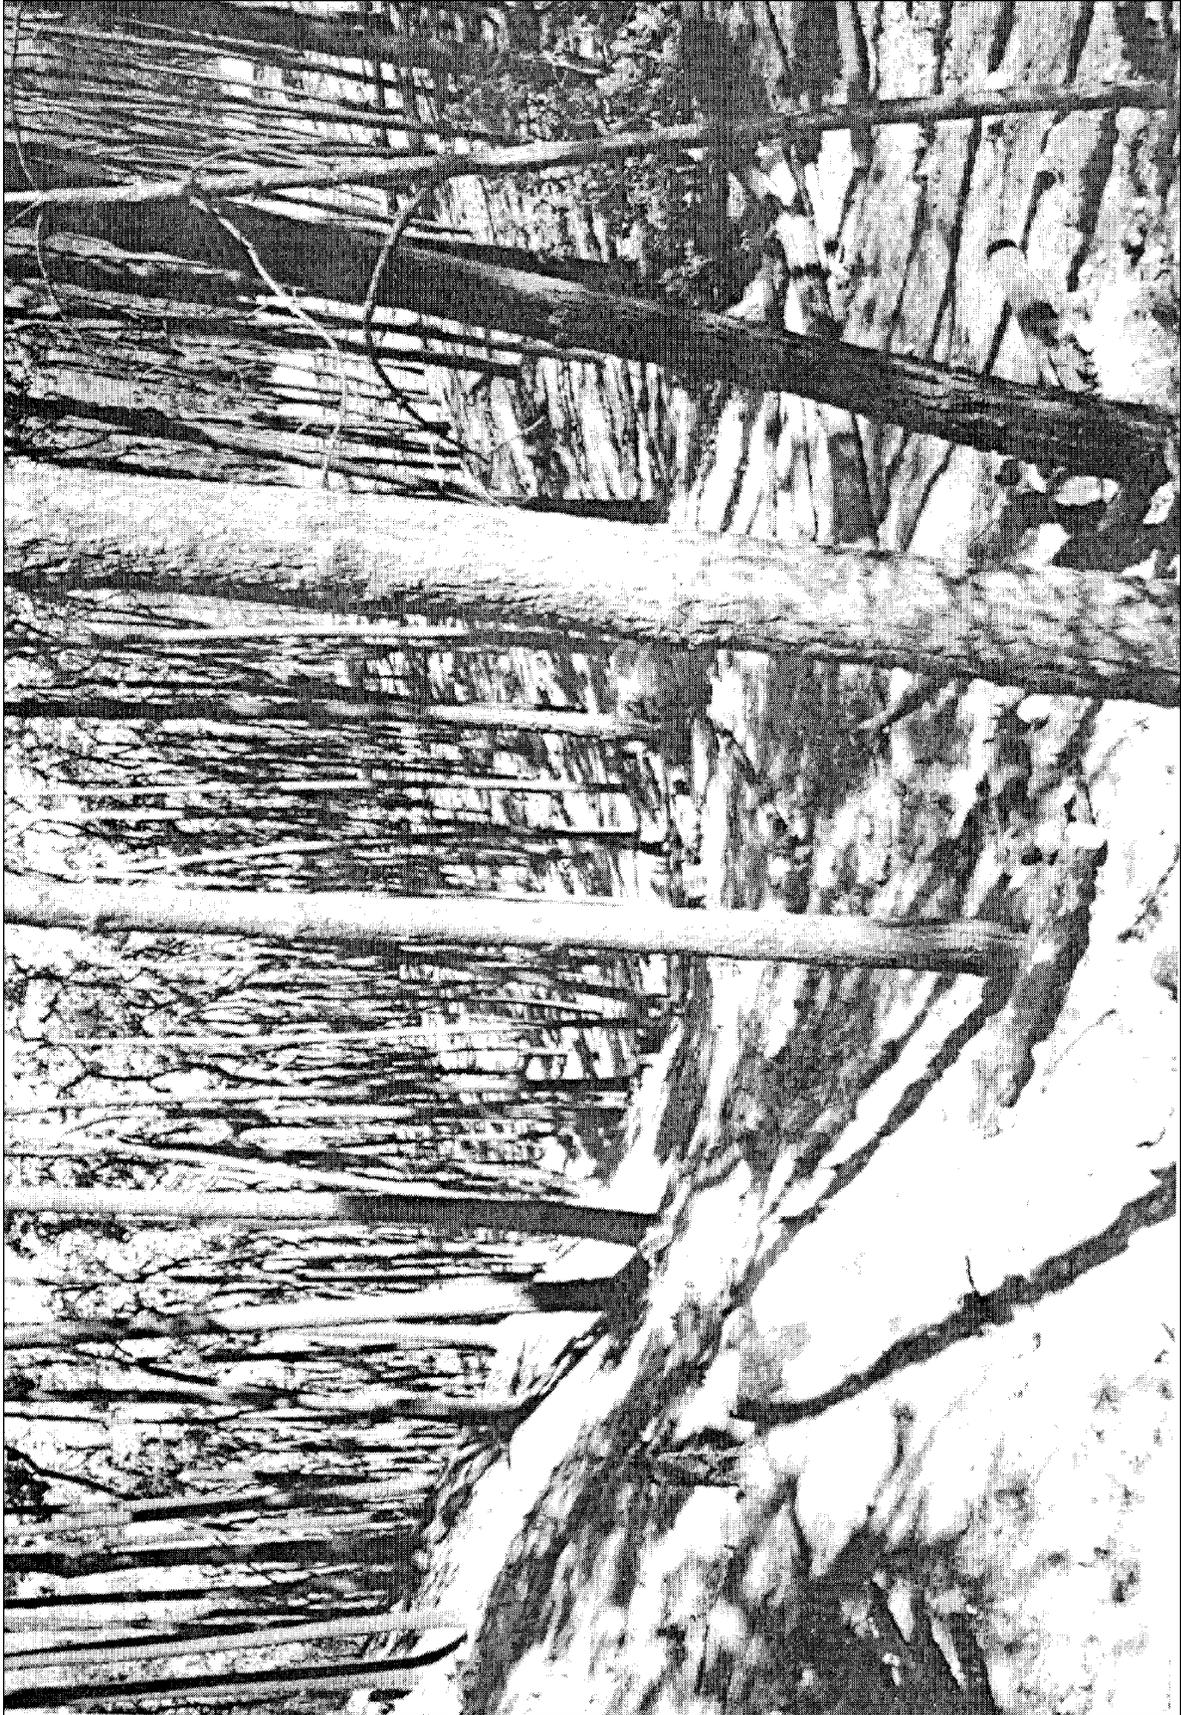
- *R1x15 - A view looking west/southwest from Los Altos Drive down the canyon or chimney in front of 4011 Los Altos Drive. Notice the intensity of the fire indicated by the complete burning of all materials in the area. Drowning also occurred along this portion of the ridge.

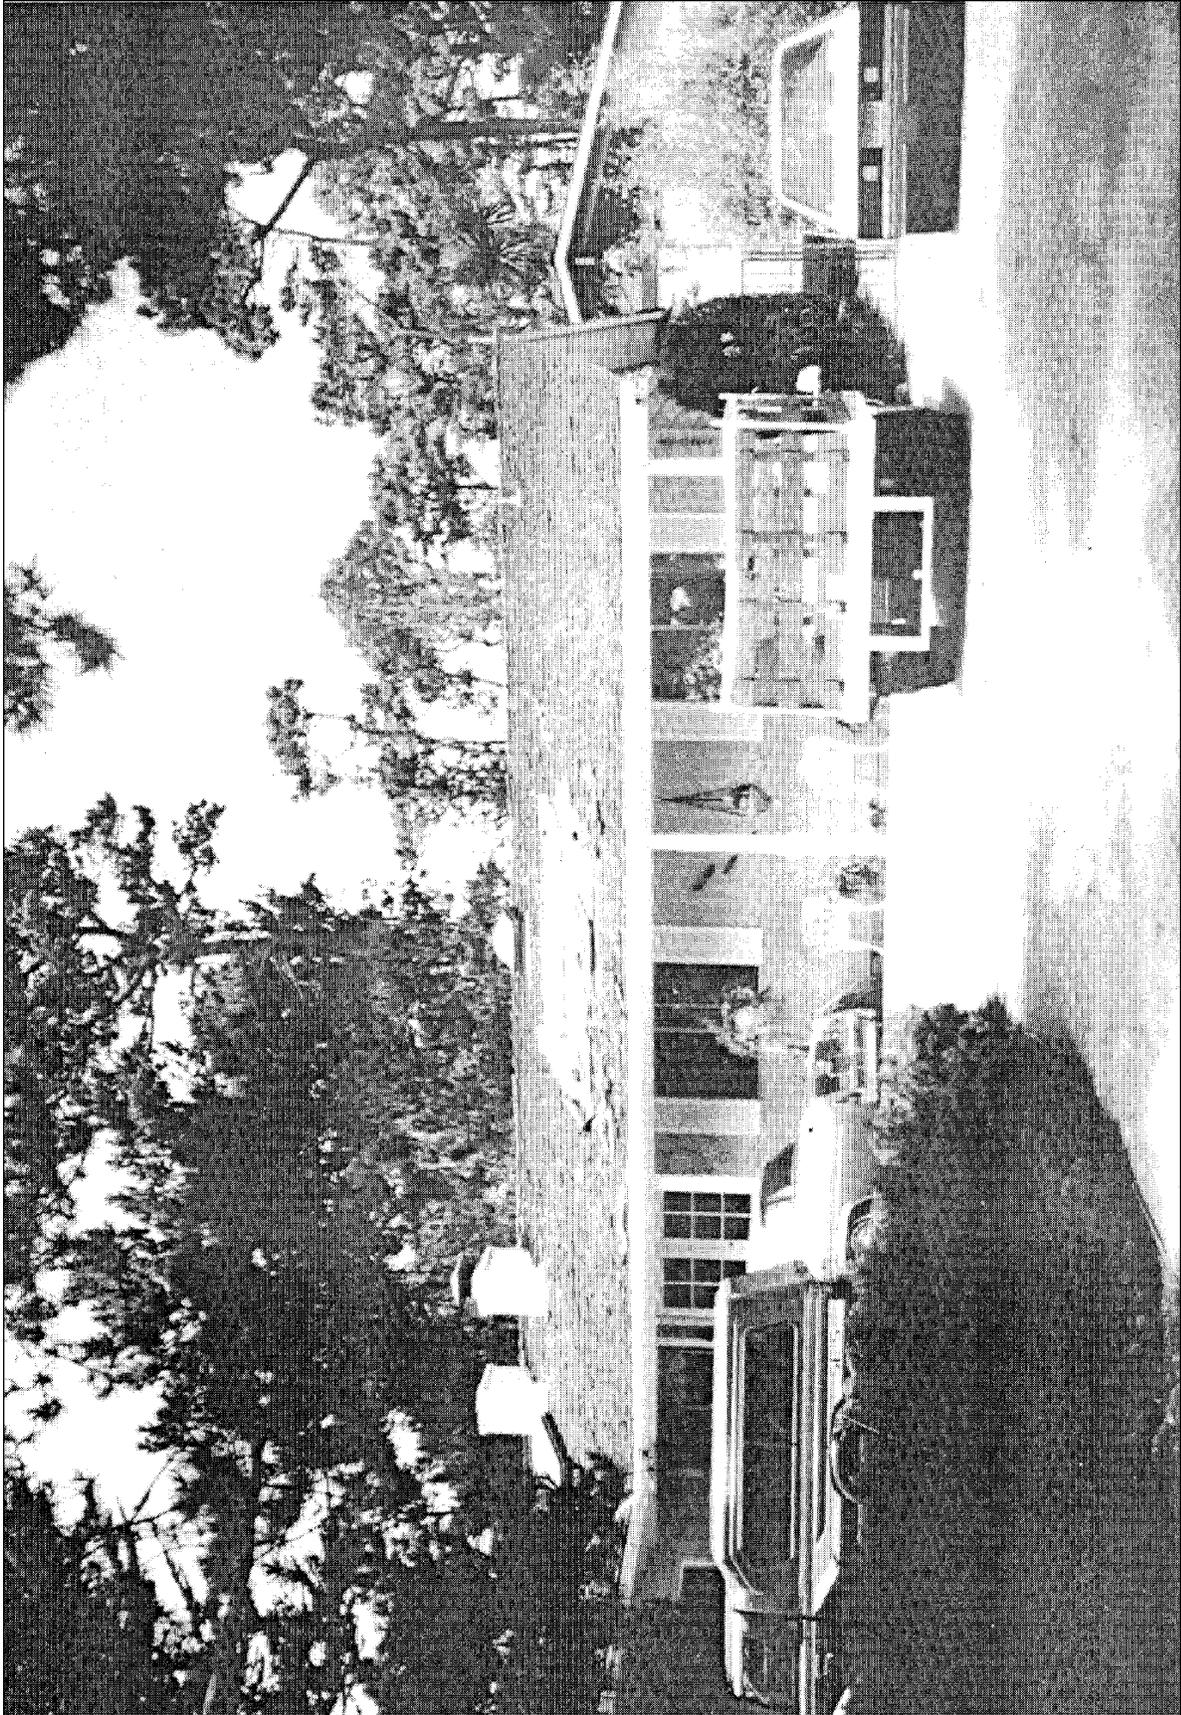
- *R2x5 - A view of some of the typical spot damage to wood shingle or wood shake roofs around the area. Note the covering over an area where a hole has burned through the roof at this house.

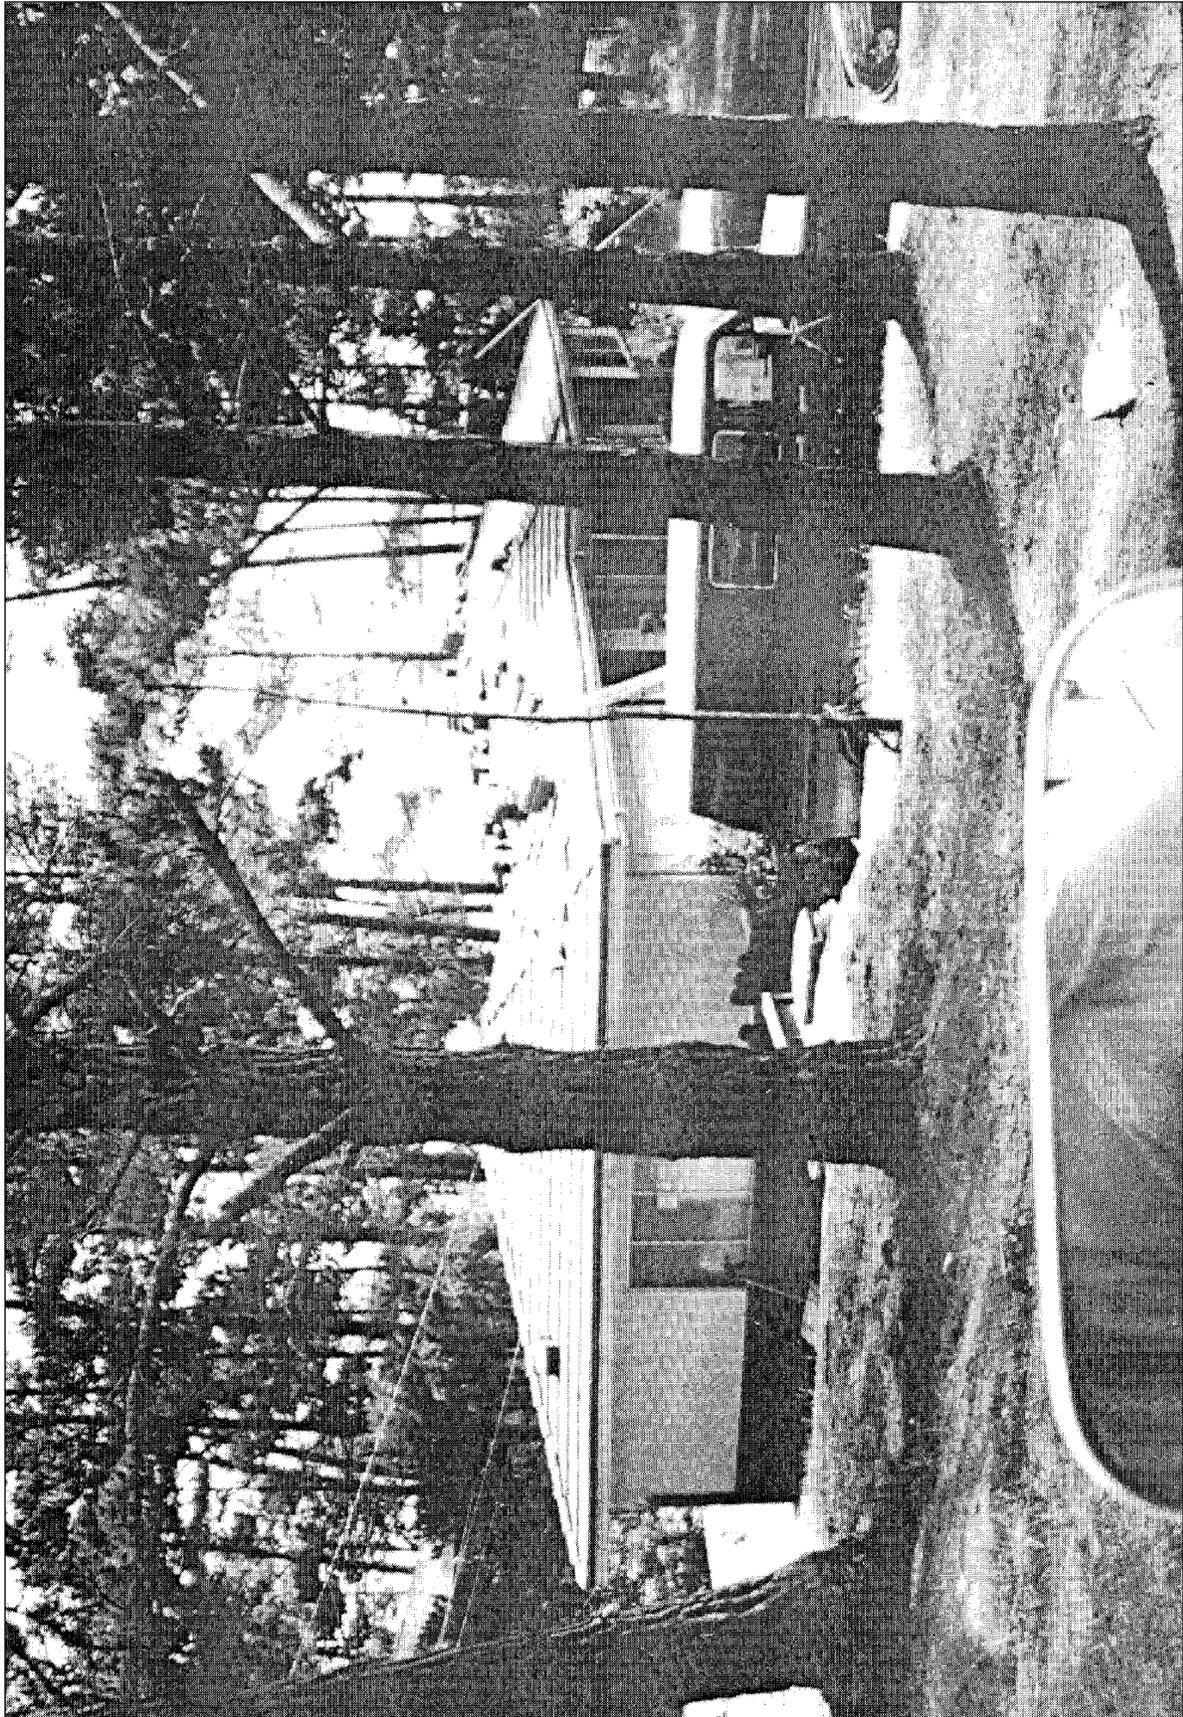
- *R2x2 - An example of some of the aftermath of the fire. This house had minor roof damage and previously had a wood shingle roof. As can be seen, the house is now having the roof replaced with tile.
