Interstate Bank Building Fire

Los Angeles, California

USFA-TR-022/May 1988

This is Report 022 of the Major Fires Investigation Project conducted by TriData Corporation under contract EMW-8-4321 to the United States Fire Administration, Federal Emergency Management Agency.

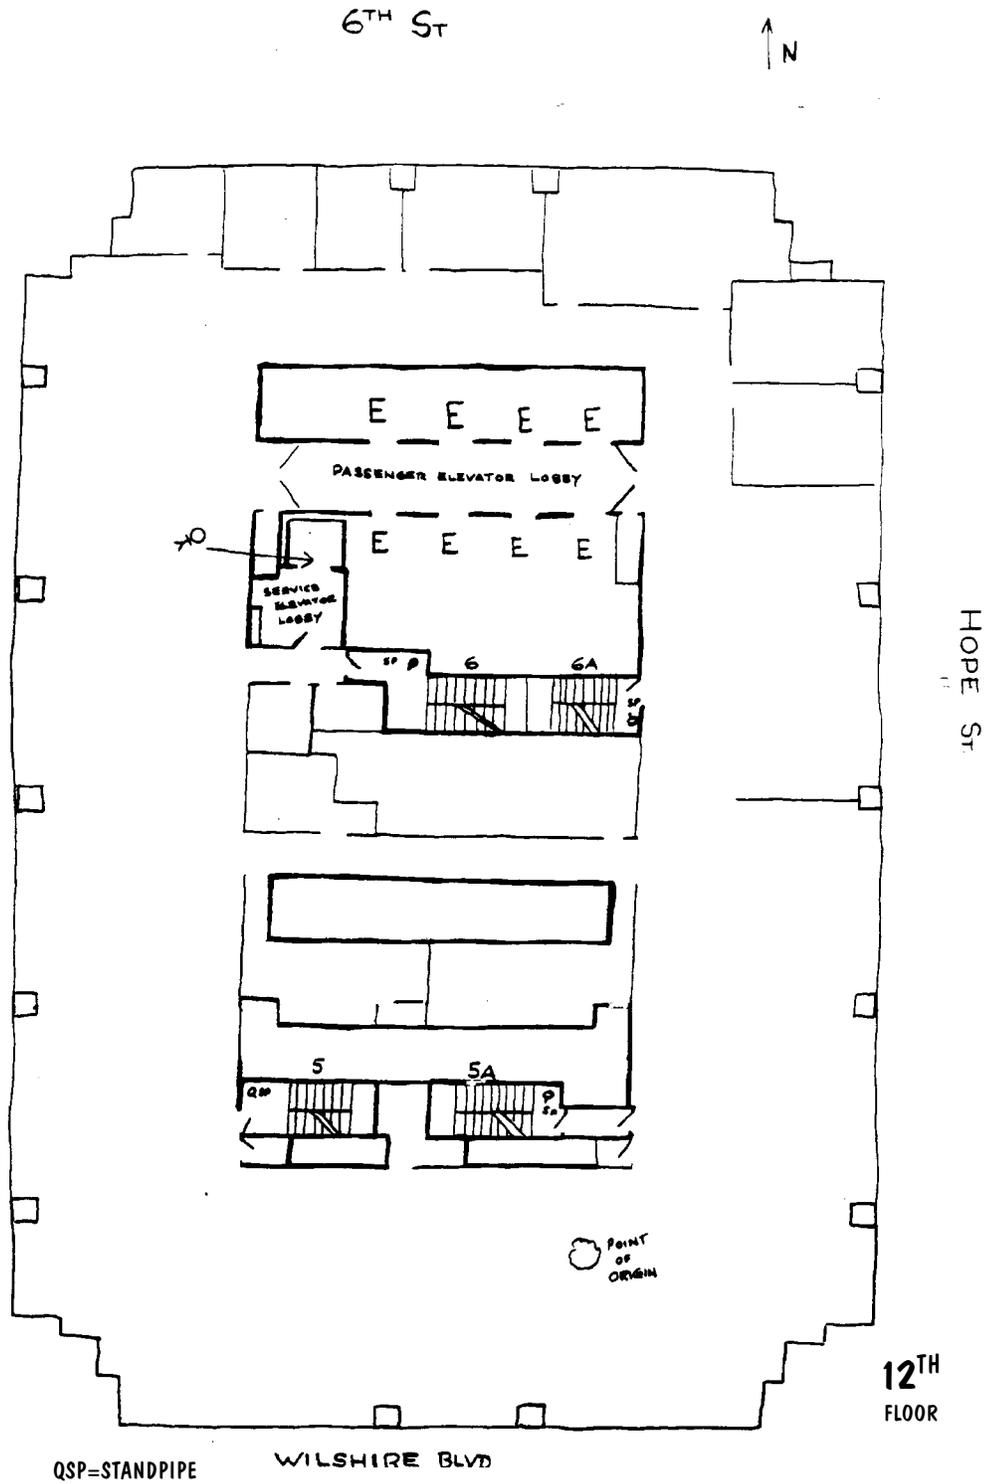
APPENDIX A

The fire originated in an open-plan office area in the southeast quadrant of the 12th floor. (See Appendix A.) The area of origin contained modular office furniture with numerous personal computers and terminals used by securities trading personnel. The cause is thought to be electrical in origin, but the precise source of ignition was not determined. The fire extended to the entire open area and several office enclosures to fully involve the 12th floor, except for the passenger elevator lobby, which was protected by automatic closing fire doors.

The single fatality was found in a service elevator. The building employee, who went to the 12th floor to investigate the alarm, was trapped and died when the elevator opened into a burning lobby. The lobby fire separation was compromised by a cleaner's cart blocking the door open. The victim was able to call for help on his portable radio, but other employees had no means to rescue him. This elevator was put on independent service through the use of a key by the building employee.

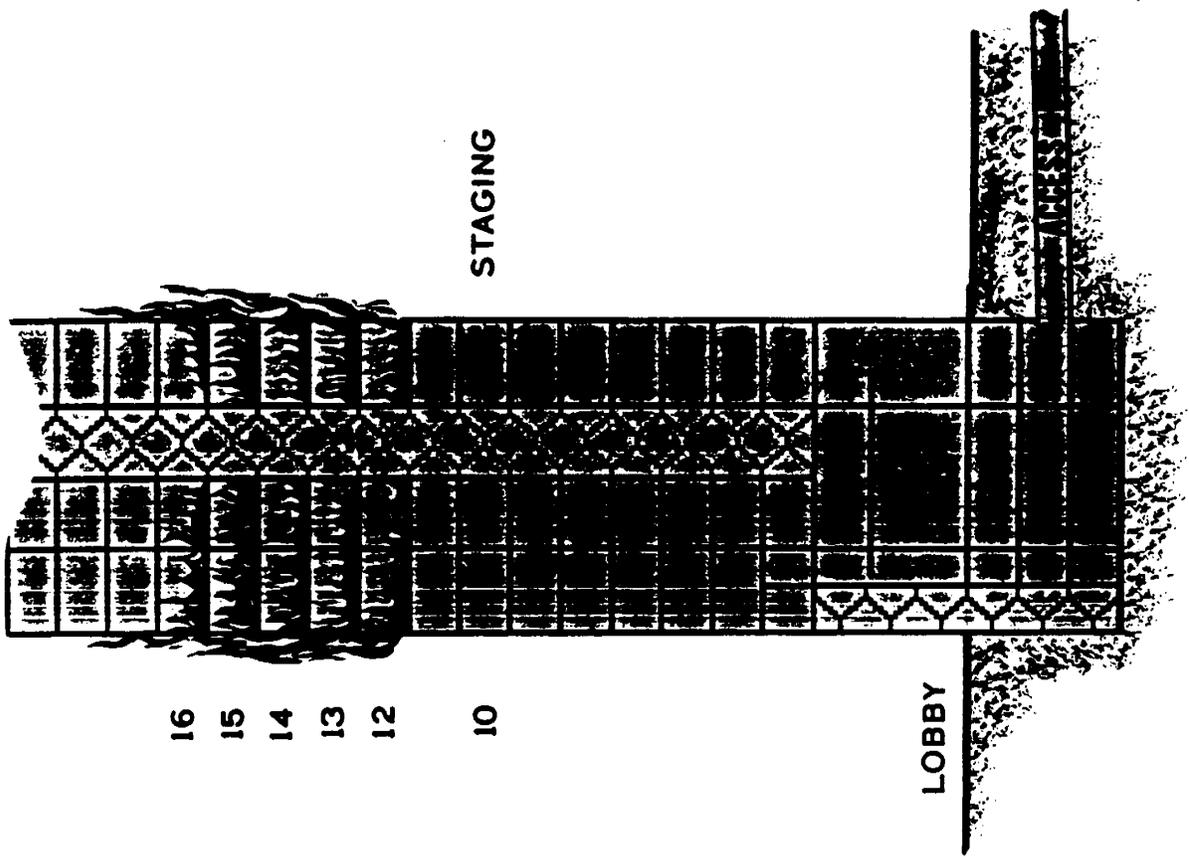
APPENDIX D

The fire extended at a rate estimated at 45 minutes per floor and burned intensely for approximately 90 minutes on each level. This resulted in two floors being heavily involved at any point during the fire. The upward extension was stopped at the 16th floor level, after completely destroying four and one-half floors of the building.

It soon became evident from the exterior and the interior that the fire was spreading upward. Companies successively launched attacks from all four stairways onto the 13th, 14th, 15th, and 16th floors, often encountering heavy fire from the point of entry and having to fight their way onto the floors with handlines. At times active suppression efforts were underway simultaneously on four levels as crews attempted to push the fire back from the central core to the perimeter of each floor. As more doors were opened, conditions in the stairways deteriorated with heat and smoke going up and water cascading down. (Appendix D shows a vertical cross-section of the building and the fire floors.)

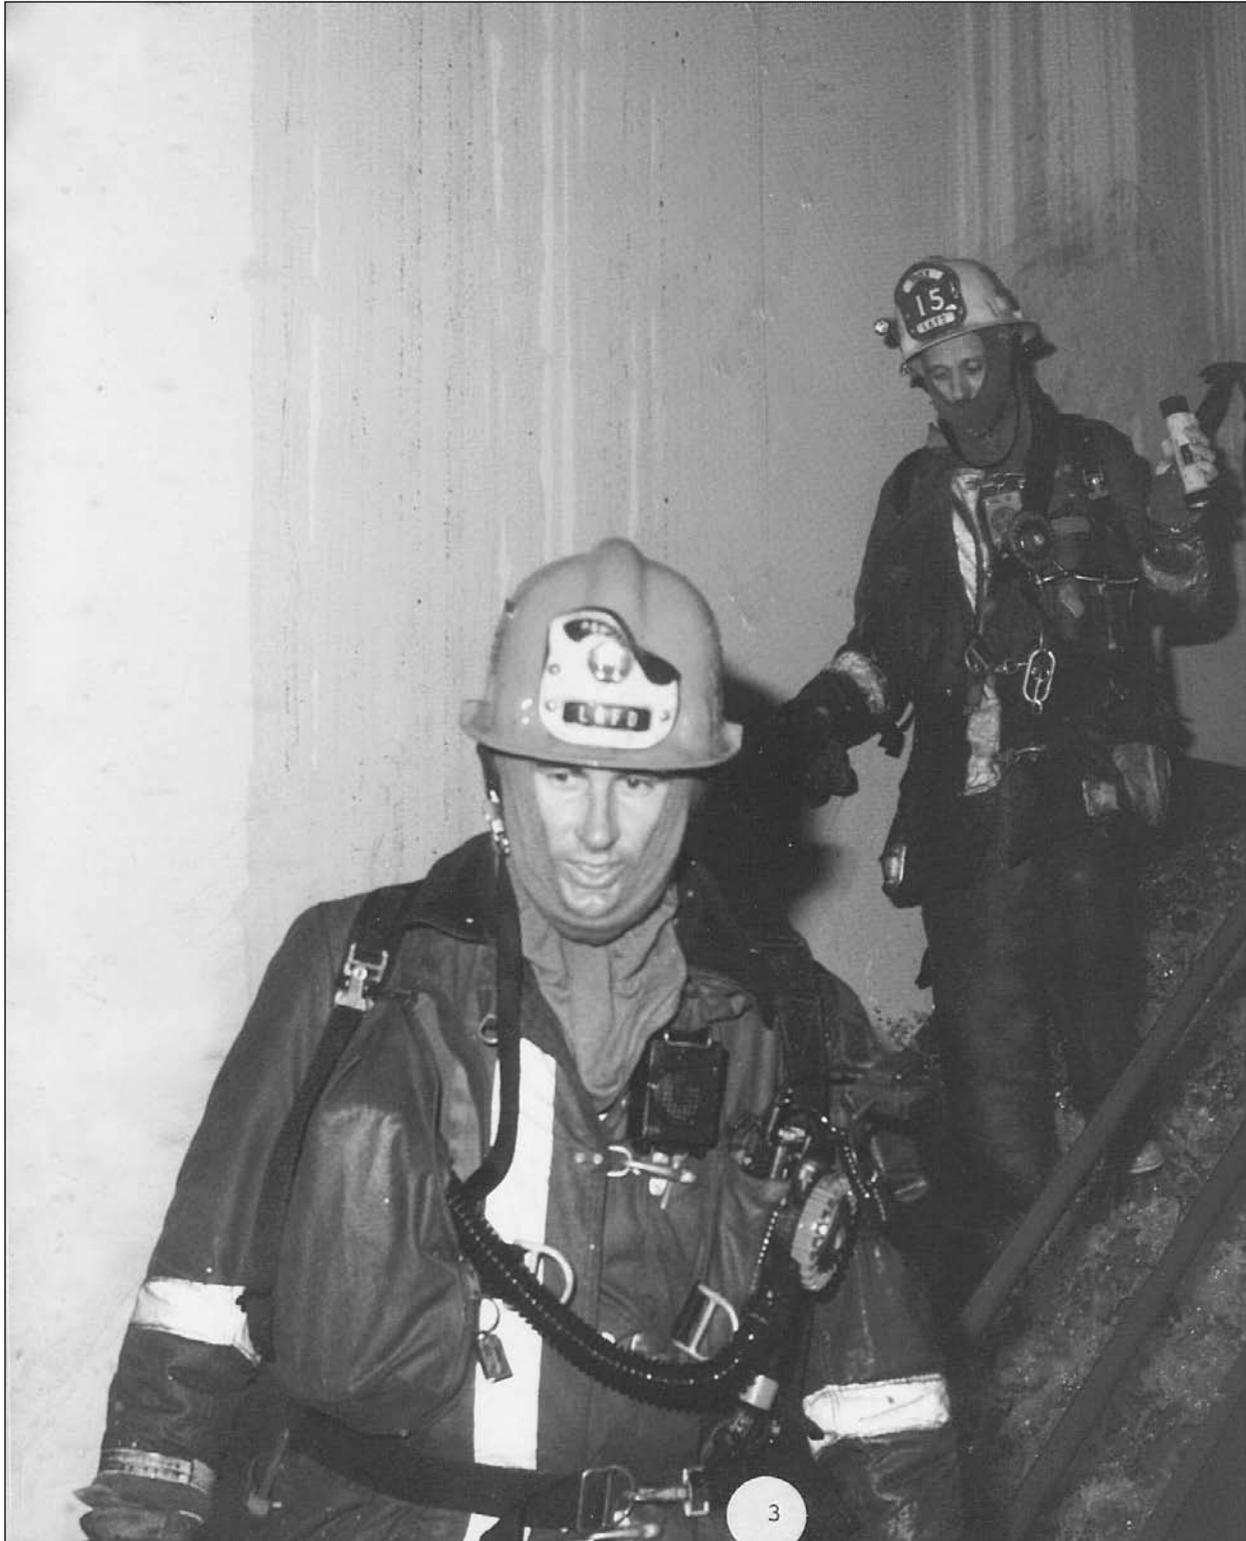
The heat conditions encountered by attack crews were severe, and the use of protective hoods was credited with preventing ear and neck burns as the crews advanced lines into involved floors. No burn injuries were reported.

3. Task Force 15 returning to staging – note hoods and water in stairwell.

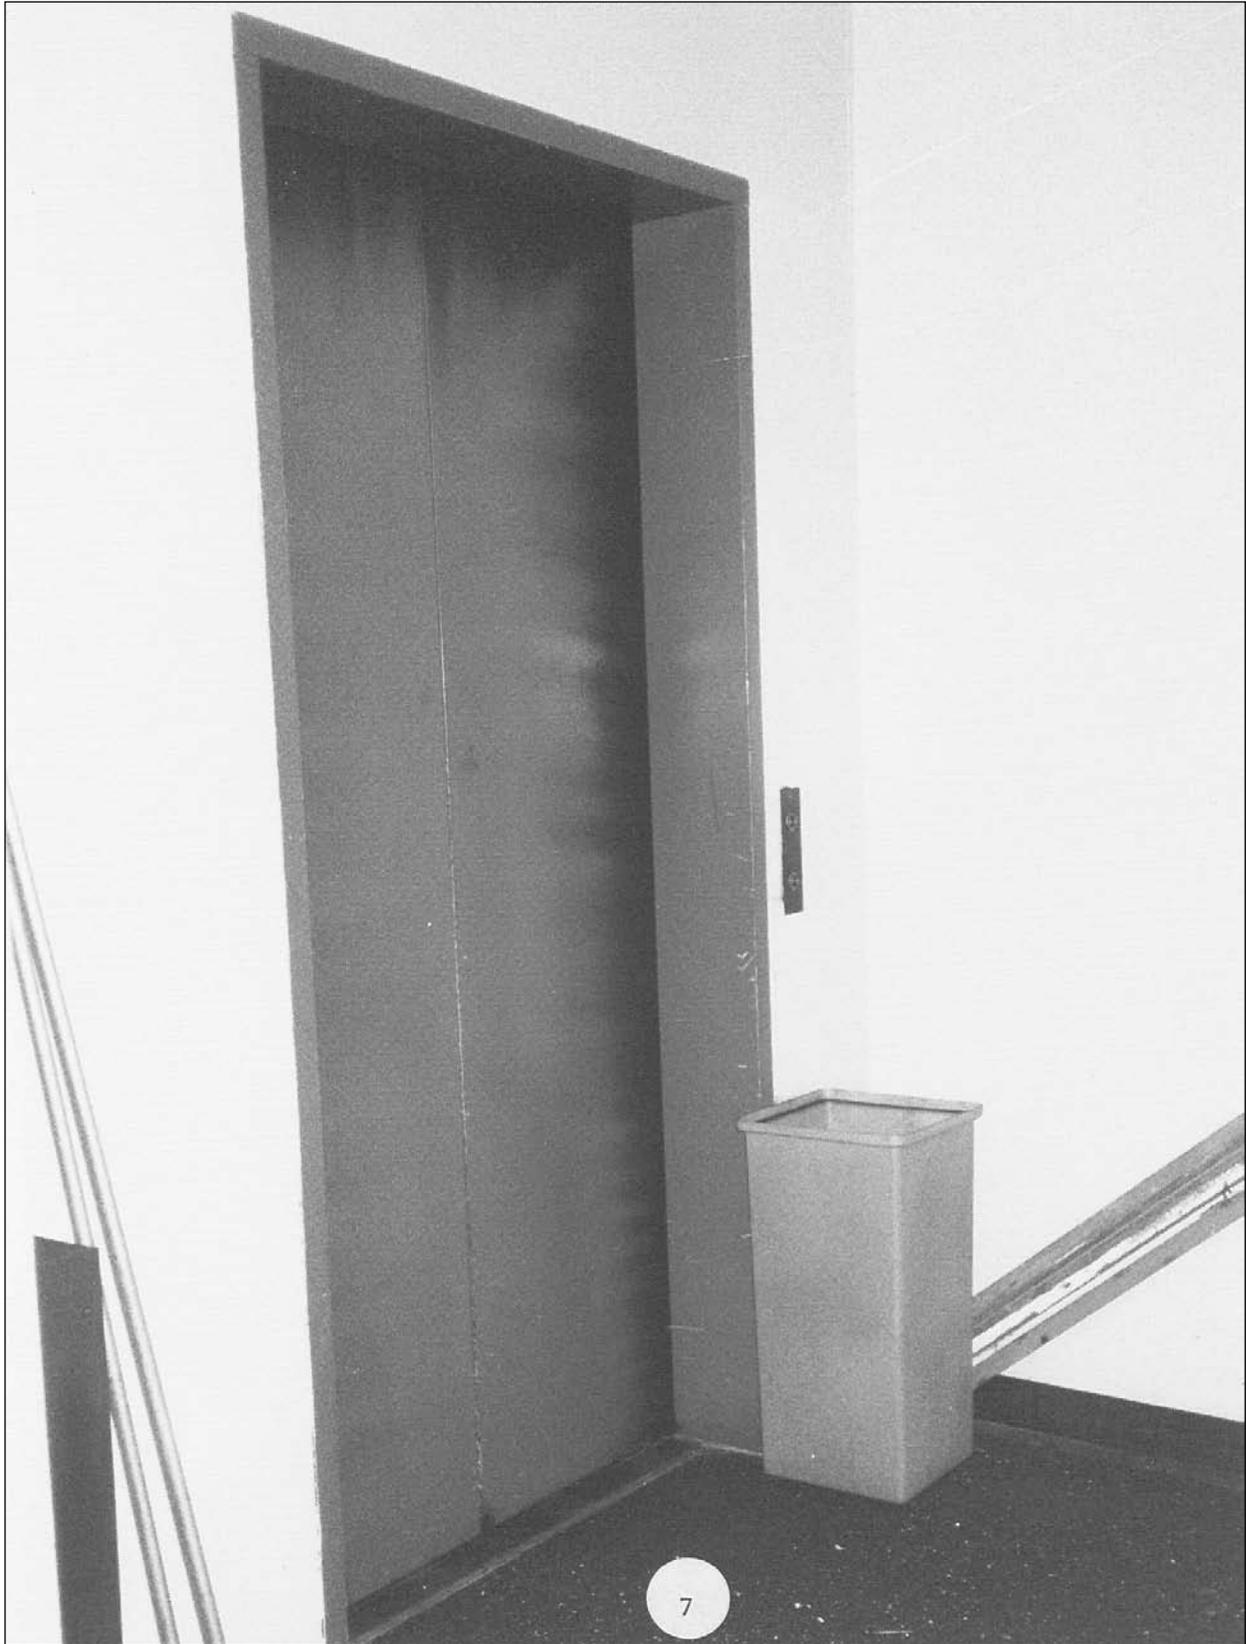
Lobby isolation doors had been installed on the passenger elevator lobbies of several floors, including the 12th and were successful in keeping fire and smoke out and providing a potential area of refuge. The isolation doors were being installed as the building was renovated. The fire reached the elevator shafts on floors where the doors had not been installed, and they became additional vertical conduits for heat and smoke. The machine room on the 22nd floor, which served the "low rise" elevators, received extensive heat and smoke damage. Smoke traveled throughout the building above the 12th floor via the elevator shafts.

7. Evidence of smoke in elevator shaft at 42nd floor.

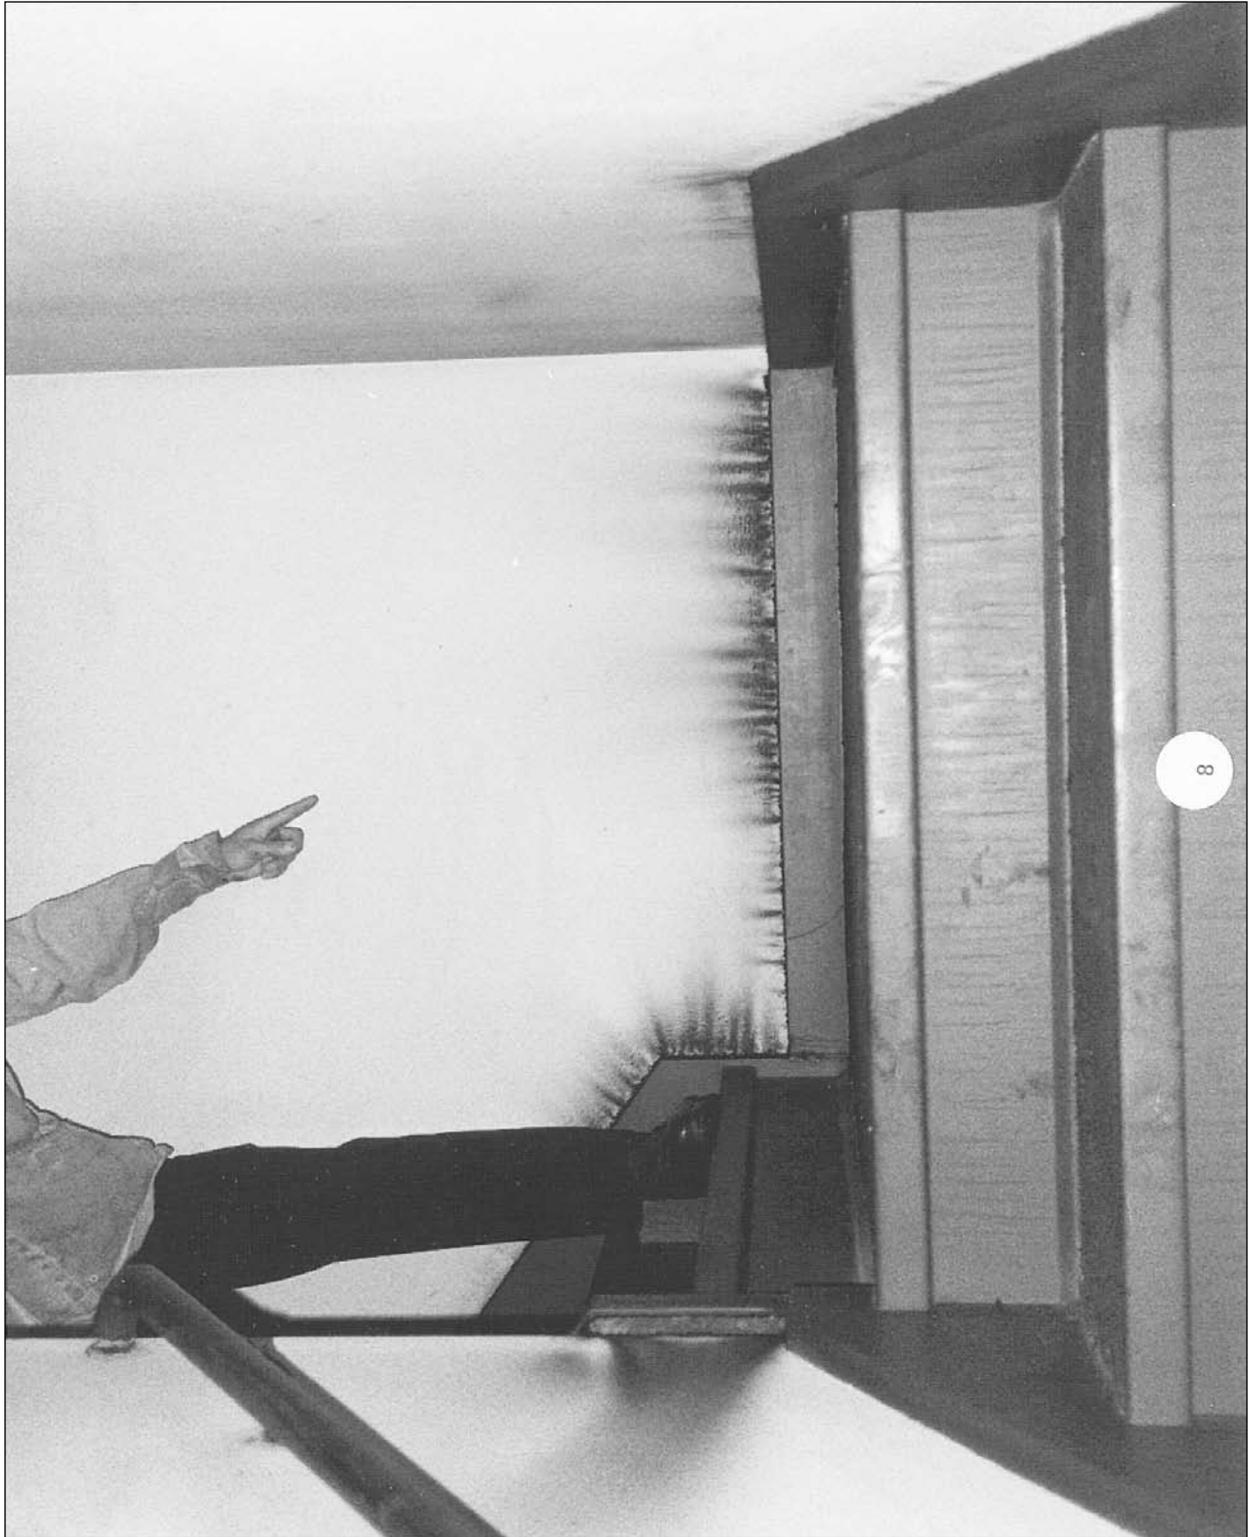
The concept of maintaining at least one stairway free of smoke, to be used for evacuation, proved ineffective in this incident. This concept may be valid for a less severe fire, but when the fire reaches this magnitude all vertical shafts become potential chimneys. The ventilated vestibule design failed to keep heat and smoke out of the pressurized smoke tower.

8. Stairwell 6 at 22nd floor showing smoke leakage.

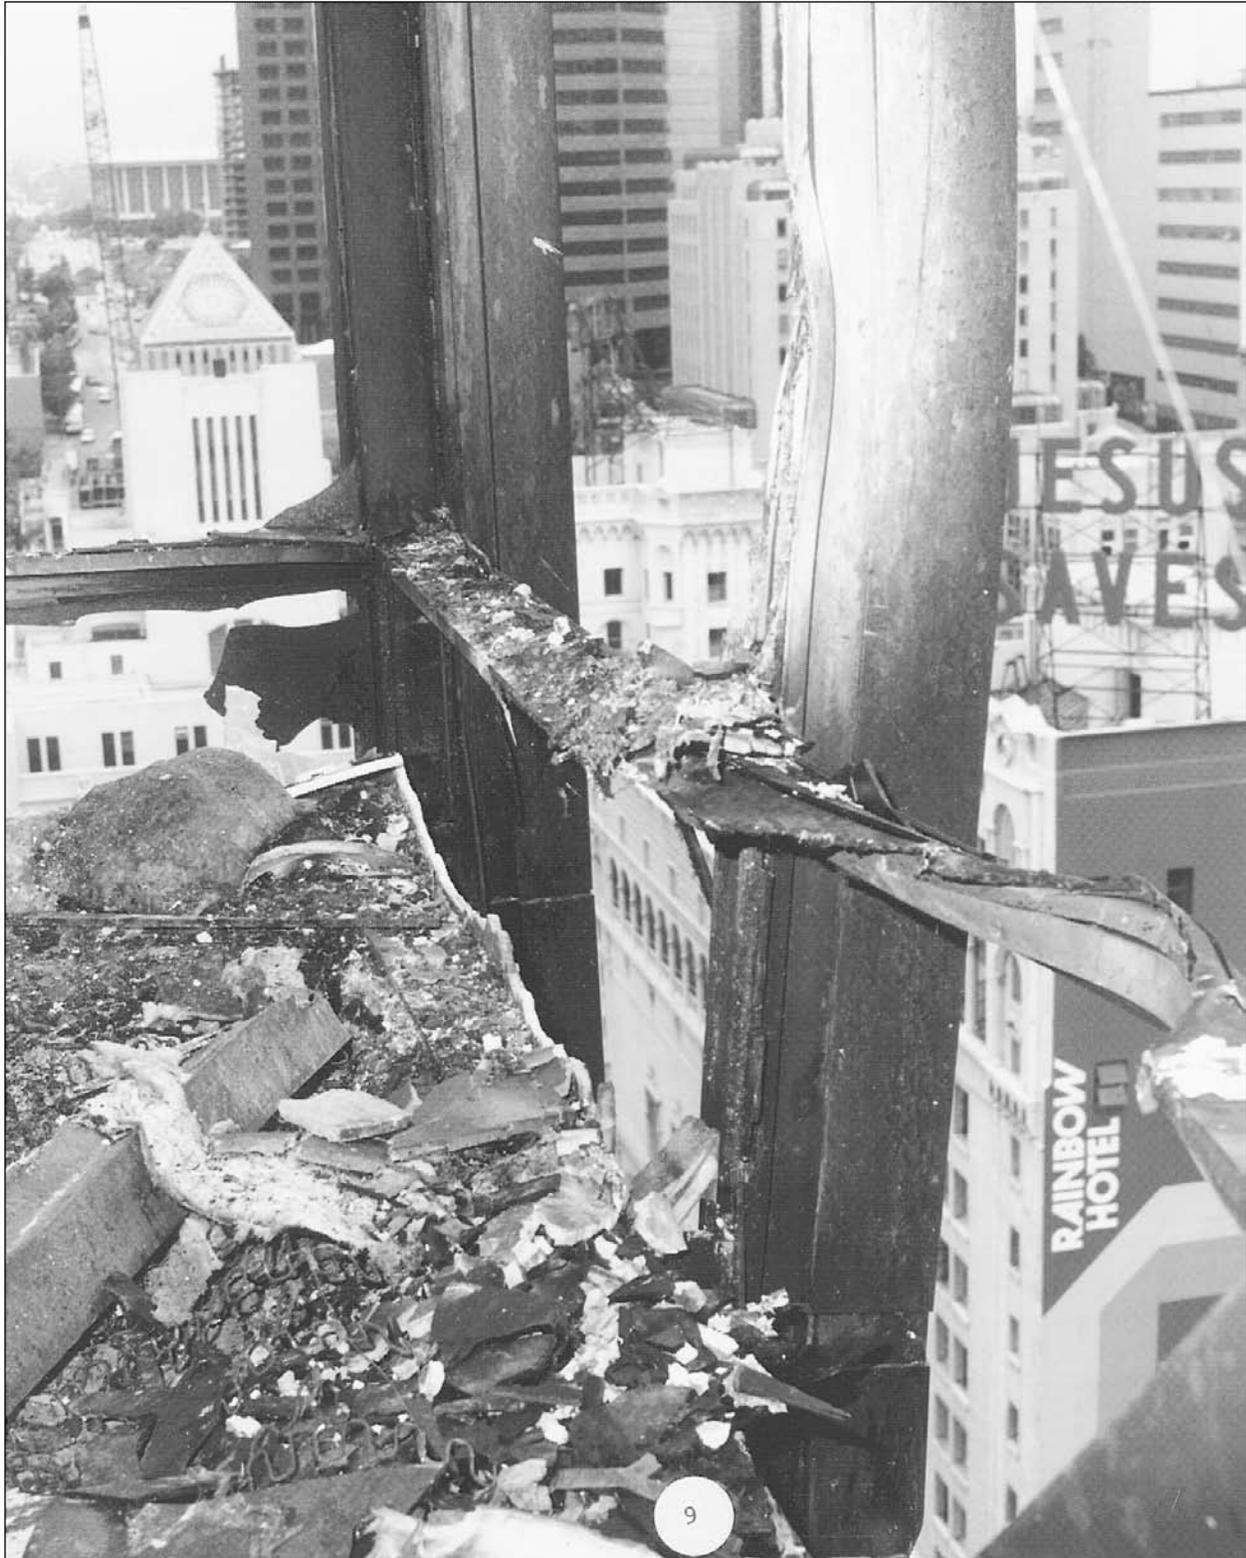
There was heavy exposure of flames to the windows on successive floors as the fire extended upward from the 12th to 16th floors. The flames were estimated to be lapping 30 feet up the face of the building. The curtain walls, including windows, spandrel panels, and mullions, were almost com-

pletely destroyed by the fire. There were no “eyebrows” to stop the exterior vertical spread, and fireground commanders were concerned about the possibility of the fire “lapping” higher to involve additional floors.

9. Twisted aluminum framework northeast corner of building.

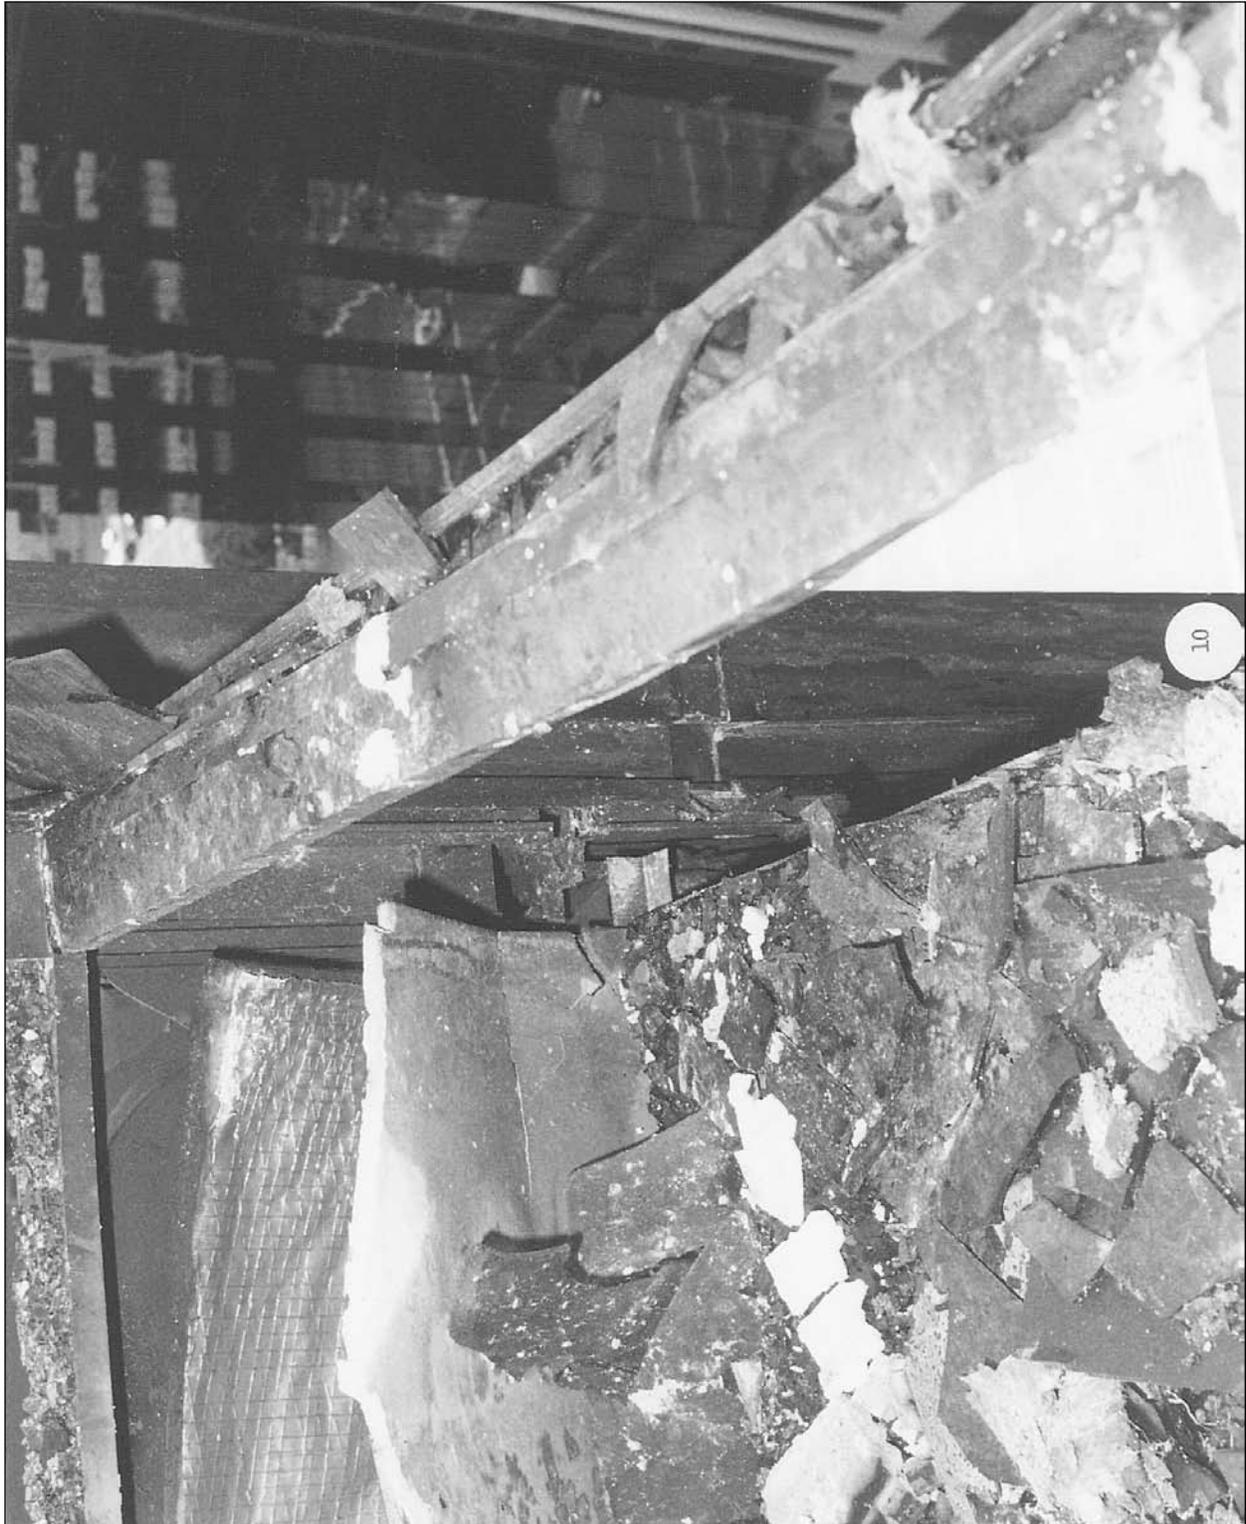
The fire extended to floors above, primarily via the outer walls of the building; windows broke and flames penetrated behind the spandrel panels around the ends of the floor slabs. The curtain wall construction creates separations between the end of the floor slab and the exterior curtain wall. (For a discussion of this type of fire spread see National Fire Protection Association (NFPA) *Fire Journal*, May/June 1988, pages 75-84.)

Minor fire extension also occurred via poke-through penetrations for electricity and communications, via heating, ventilation, and air conditioning (HVAC) shafts, and via heat conduction through the floor slabs. A minor fire occurred in a storeroom on the 27th floor, ignited by fire products escaping from an HVAC shaft that originated on the 12th floor. This fire self-extinguished due to oxygen deficiency, but could have greatly complicated the situation if it had continued to burn. The secondary extensions were minor compared to the perimeter fire spread at the curtain walls.

10. Void between floor and exterior glass.

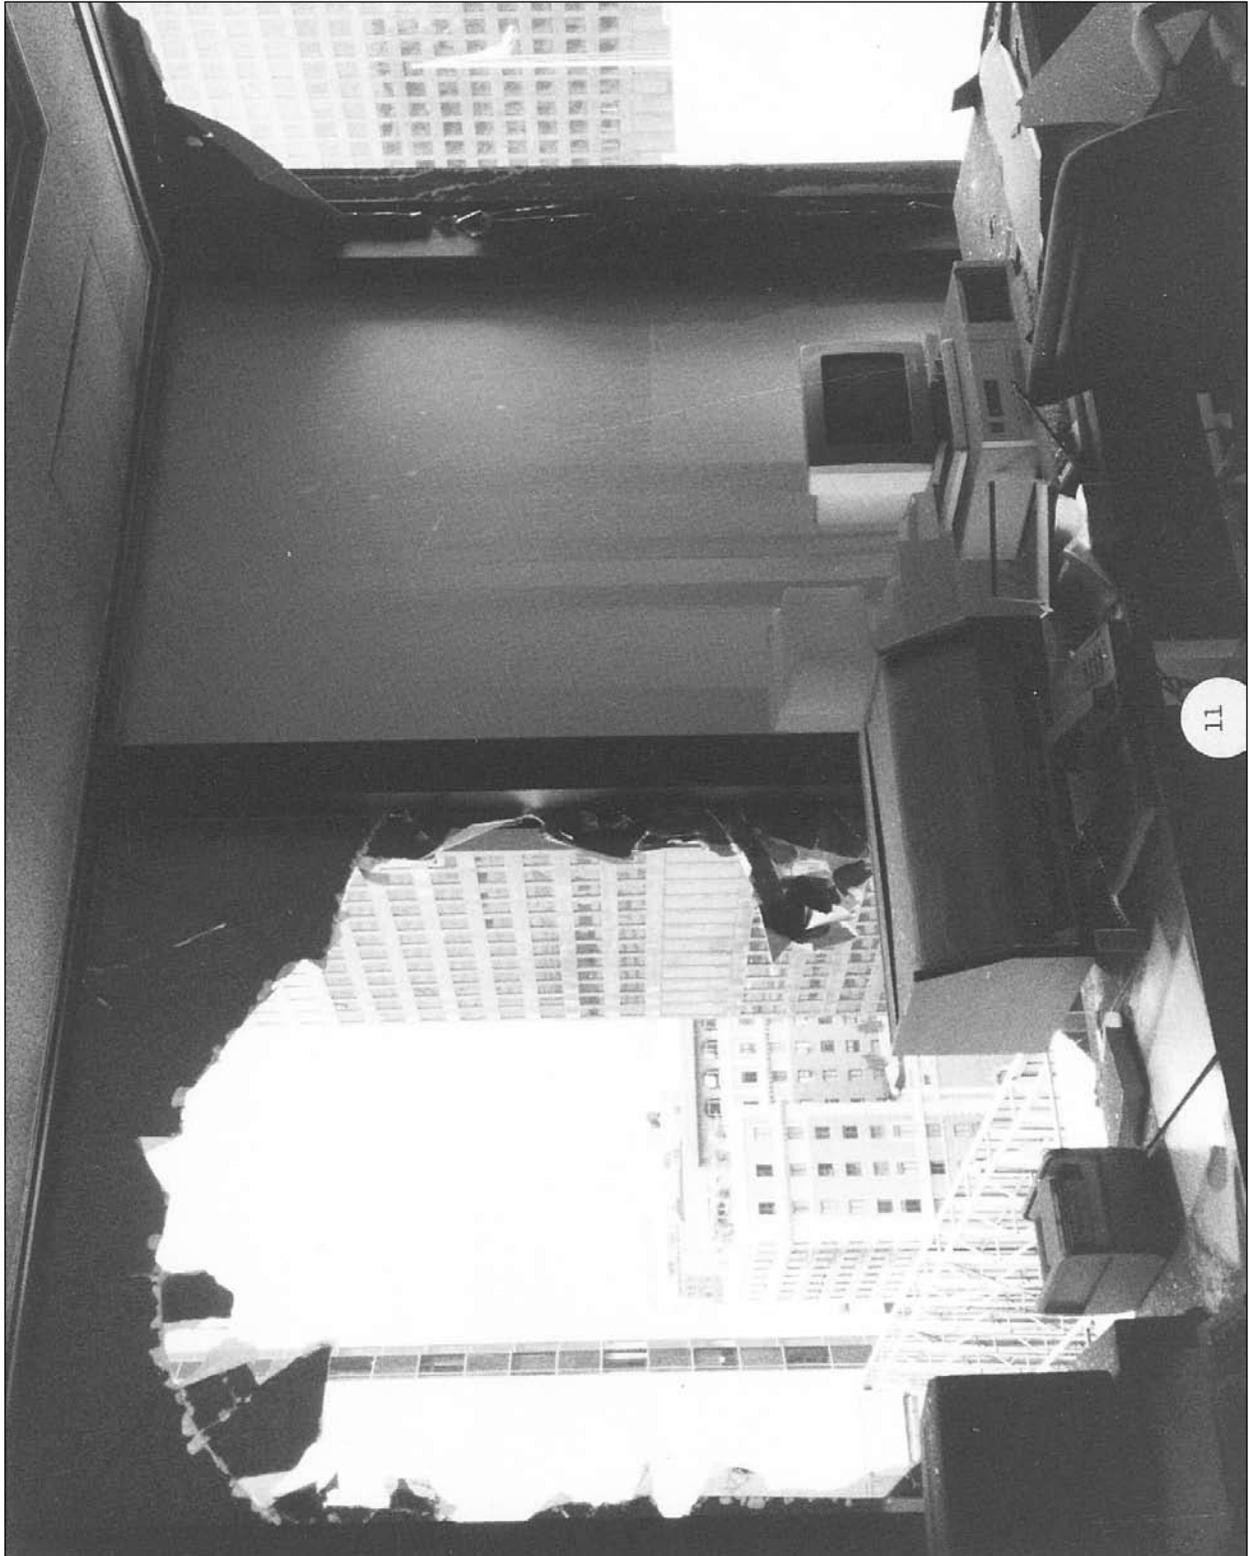
Falling glass and other debris created a major problem during this incident. Virtually all of the exterior curtain wall, from the 12th through 16th floors, was destroyed and fell to the ground. The falling glass and debris caused significant damage to pumpers hooked up to the fire department connections. The hoselines were cut several times and had to be replaced, under the constant danger of additional falling materials. The entire perimeter of the building, for over 100 feet out from the walls, was littered with this debris.

The windows were coated with a plastic reflective material which caused them to hold together as they fell. The glass fell in very large sections, some of which were flaming due to ignition of the plastic coating.

11. Plate glass windows on the 16th floor.

This has been a common problem at major highrise fires such as the Prudential fire in Boston. Large sheets of glass can act as guillotines. The existence of a tunnel for safe entry of personnel was fortuitous in this fire. Plans for new highrises should be reviewed for protected access by emergency personnel. Pre-fire plans for existing highrises should be reviewed as to how the local fire department would cope with this hazard.
